Manhole Inspection Summary

Manhole # S25KK_007MH

Location Address: **2133 TIFFANY ALLEY**

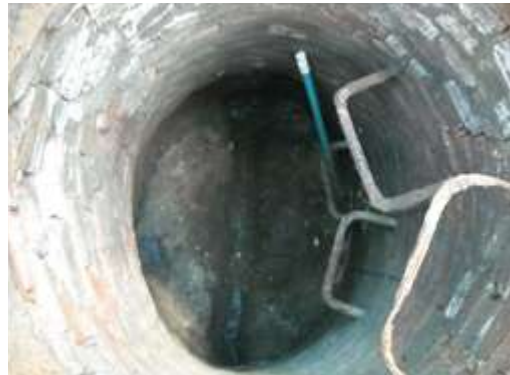
Top View

Corroded steps. Evidence of surcharge - Bench debris. Channel debris.

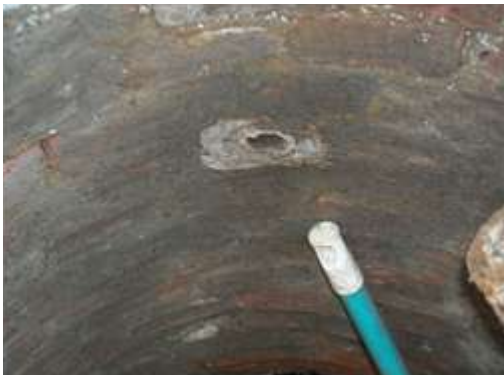
1" pipe in Corbel

Illicit connection?

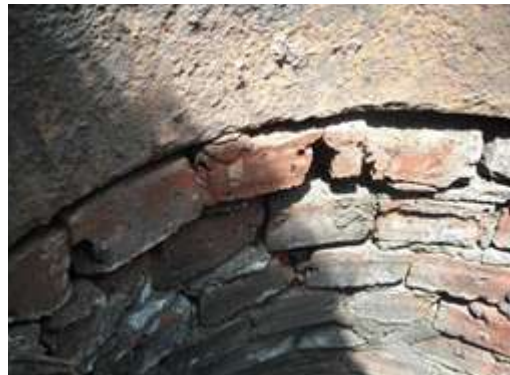
Defect

Frame leaks. Corbel deterioration, loose brick and infiltration.

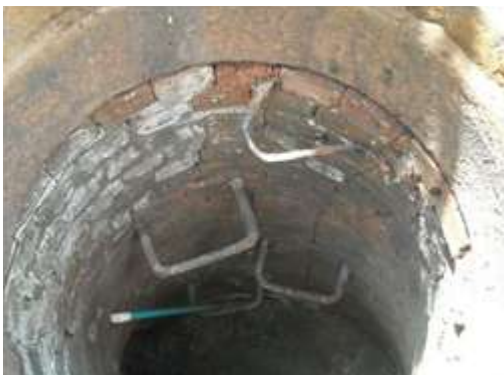
Defect

Frame leaks. Corbel deterioration and infiltration. Barrel infiltration.

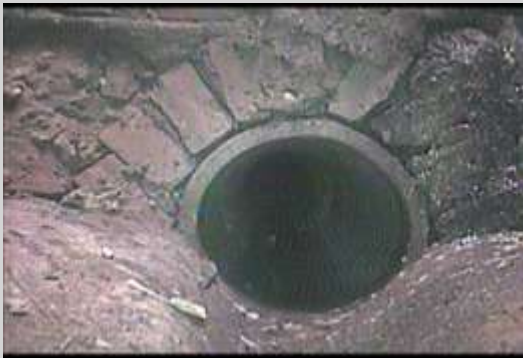
8 in. Circular Gravity Sewer Pipe Out @ 12 O'Clock

Infiltration: **None** Pipe Seal Cond: **Cracked**

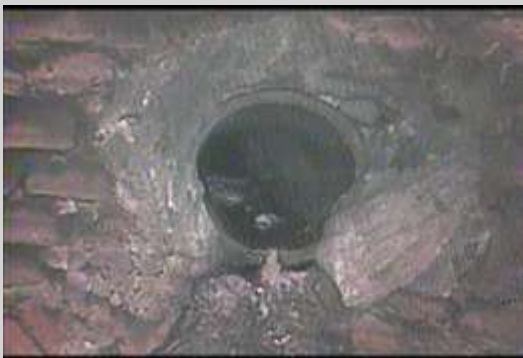
8 in. Circular Gravity Sewer Pipe In @ 1 O'Clock

Deposits: ☐ None ☒ **Mud** ☐ Sludge ☒ **Debris** ☐ Grease

Silt Depth: **1** (in.) Deposits Extent: **Light**

Infiltration: **None** Pipe Seal Cond: **Broken**

☒ **Possible Illicit Connection**
